# Wear and damage characteristics on friction brakes

- Disc brake -

1<sup>st</sup> edition / 2007

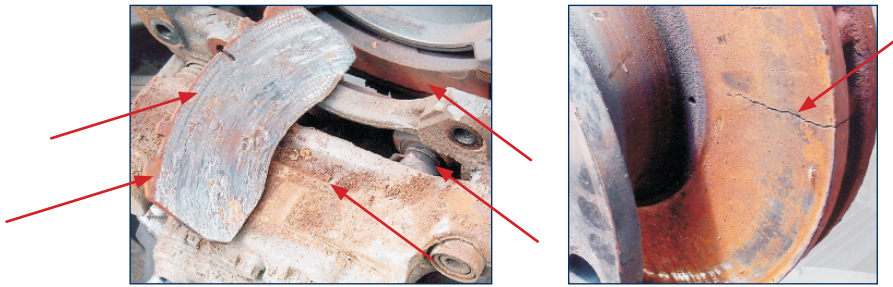
## 8.1 Damage pattern: Thermal destruction of the brake and extreme pad wear

The brake calliper has a reddish discolouration, in particularly on the piston side and in the brake cavity, and is covered with a layer of corrosion.

One covering boot of the piston has already been destroyed. The brake pad lining plate of the pad is worn along the entire surface and has a noticeable red discolouration in the edge area. Remains of the metal grid attachment are still visible in places, the brake pad is completely worn down.

The brake disc has red discolouration. The braking surface facing the hub neck is covered with flash rust, there are only bright spots remaining in the outer edge area. A continuous crack can be seen in the brake disc. There are other smaller heat cracks below the layer of flash rust.

The brake pads wear faster if a disc brake is exposed to high temperatures. If this is not noticed in good time by inspection and maintenance work, the brake pads may wear down completely with the result that the brake pad lining plates start making friction contact with the brake disc. This metal-on-metal friction can lead to temperatures in the forging and smelting range at some points. This heat acts on almost all brake components and the braking surfaces of the disc. Only the screw-on surface of the hub neck and parts of the brake calliper are not exposed to such high temperatures - some remnants of the original paint can still be seen here.

If there is damage on all the brakes of a vehicle, it may have been caused by an aggressive driving style, incorrect matching between the tractor and trailer or brakes that are too small for the application.

If there is damage on individual wheel brakes, it may have been caused by a defect in the particular wheel brake or a defect in the brake pressure pneumatic circuit in question.

The destruction of the covering boot of the piston can allow moisture and dirt to penetrate the brake calliper and lead to corrosion. This destroys the adjusting device. The brake calliper and the overheated, cracked brake disc are unusable.

All worn and overheated components must be renewed. We recommend using genuine parts.

If the damage has occurred on all brakes of a vehicle, the matching between the tractor and the trailer should be checked if possible. A careful and predictive driving style can help to avoid such overloadings of the brake.

If there is damage on individual brakes, the components and the affected brake pressure pneumatic circuit must be checked and repaired if faulty.

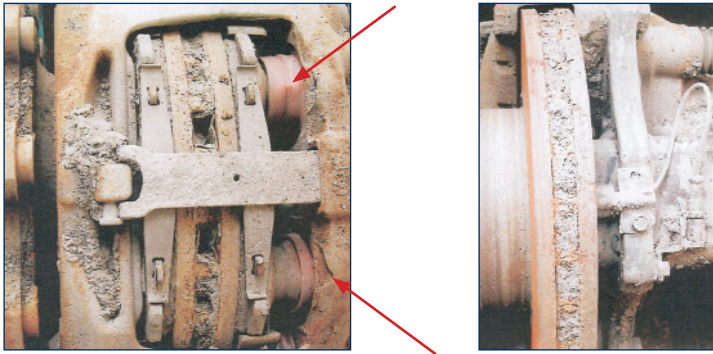
## 8.2 Damage pattern: Extreme wear to the brake in off-road use

The brake cavity and the cavities in the ventilated brake disc are blocked with earth and mud residues. The brake displays significant traces of corrosion, the stop projections of the pads have white discolouration. The seal of the piston at the top of the picture is bent over and has moved closer to the brake pad lining plate. The pads are evenly worn down.

Such advanced wear is caused by driving on very dirty or muddy roads. More and more dirt collects on and in the brake during this process. These encrustations with mud increasingly prevent the pistons and their boots from moving.

In this condition, the brake can still provide adequate braking values. However, failures can be expected within a very short period of time due to increasing obstructions of the clamping and return movements. It becomes more difficult for the brake calliper to move laterally in its sliding seat and the pistons cannot move out and in correctly any longer. This means the brake pads are not pressed against the brake disc flat. Slanting and one-sided wear results. Cooling of the brake disc by circulating air is rendered impossible because the cavities are blocked, which means overheating can be expected before very long.

A brake with this level of contamination urgently requires cleaning. Heavily corroded and damaged parts must be renewed. We recommend using genuine parts. BPW disc brake axles can be retrofitted with a cavity cover as well as the Disc Protector. These cover plates for disc brakes protect the brake against coarse dirt and extend its service life.

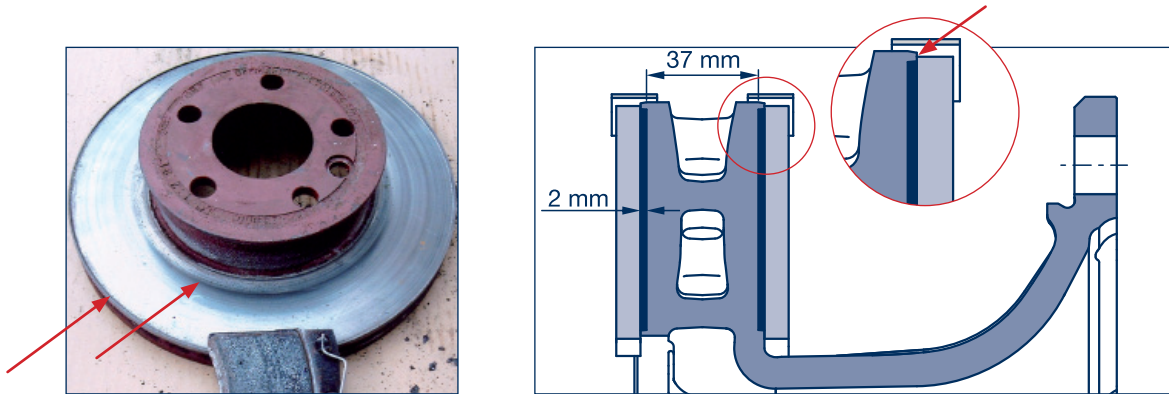
## 8.3 Damage pattern: Edge contact between backplate and brake disc

This brake disc is approaching its wear limit. Narrow wear edges have been left on the inside and outside edges of the braking surface, corresponding to the height of the original disc thickness. The braking surface is evenly worn, without distortion, scorched spots or heat cracks. The associated pads display even wear, the wear limit has been reached. It is noticeable that the brake pad lining plates have been in ring-shaped friction contact with the hub neck of the disc in the area of the outside edges.

Although the brake pads are evenly worn, they have not covered the entire braking surface. With increasing wear, the brake pads have gouged their way into the braking surface and have left wear edges on the inside and outside edges. During their use, the brake disc and brake pad have worn down in the unfavourable one-to-one ratio, which means the braking surface thickness and the brake pad thickness have diminished to an equal extent. From a certain point onwards, the height of the wear edges matched the thickness of the remaining pad. Then, the brake pad lining plates (which are wider than the brake pad) came into contact with the projecting edges during braking.

The contact pressure was no longer being applied to the brake pads and the braking surface, but instead acted on the wearing edges and brake pad lining plates. Despite having worn-down pads, a disc brake can still display adequate braking values on the dynamometer test rig. However, this can cause unwanted noise or uneven deceleration.

The wear on the brake disc and the pads must be checked regularly. The brake disc and brake pads represent a combination of materials that establish a certain amount of friction when pressed together. The softer friction partner, namely the brake pad, is intended to wear more rapidly than the brake disc. The degree to which the disc and brake pad wear relative to one another is described as the wear ratio. The edge formation on the brake disc must be assessed when the pads are changed. The edges are allowed to be ground down if the disc has not reached its wear limit yet.

It is always to be recommended that tested and approved qualities as well as mutually compatible combinations should be used

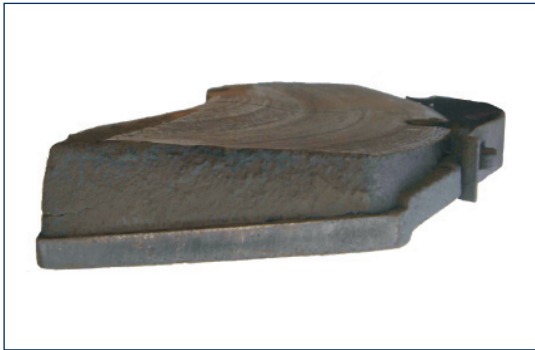
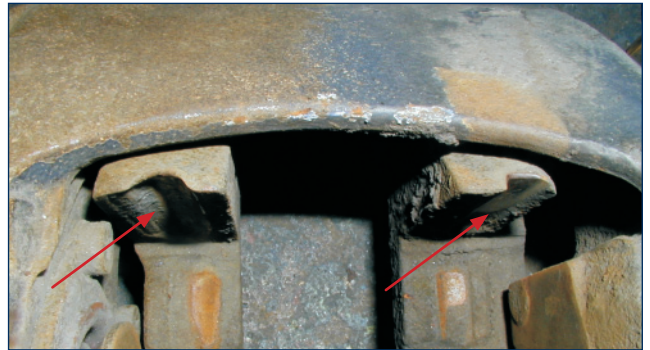
## 8.4 Damage pattern: Slanting wear due to offroad use

This brake pad reveals severe slanting wear. Significant indentations into the brake cavity can be seen on the brake calliper.

Driving on unconsolidated tracks with potholes can result in this kind of damage to disc brakes. The frequent and powerful shocks cause the brake pad lining plates to work into the brake frame, causing the pads to cant and tilt during braking.

Tilting leads to slanting wear on the brake pads. A slight amount of play is restored when the brake is released. The bearings of the brake calliper are highly stressed by the slanted pads and they wear prematurely. In addition, the slant means that the brake pads wear down very quickly. If the damage to the brake is not rectified, the brake pad lining plates will come into friction contact with the brake disc and can cause irreparable damage to it.

Damaged components must be renewed. We recommend using genuine parts.

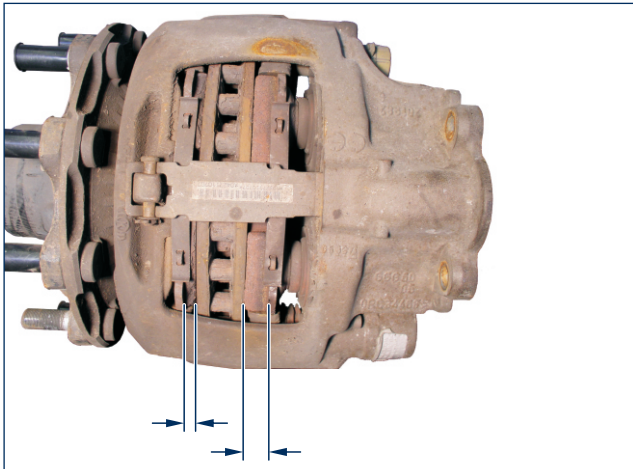
## 8.5 Damage pattern: Uneven wear due to sticking brake callipers

Severe one-sided wear on brake pads in conjunction with seized brake calliper

Leaks in the area of the guide pin allow moisture to penetrate, leading to corrosion and seizure of the pilot bearings.

The brake calliper is unable to slide back into its starting position after the brake is released, and therefore the outer pad rubs against the brake disc. This leads to increased wear on the outer pad.

The pilot bearings and bushes must be renewed if this damage occurs.

In order to prevent the damage described here from occurring, the seals of the pilot bearings must be carefully checked during inspections and renewed in case of damage.

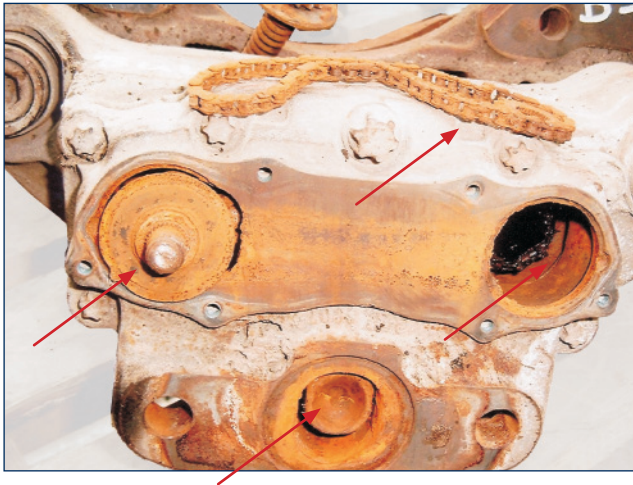
## 8.6 Damage pattern: Severe corrosion in the brake calliper

The picture shows the area of the adjusting device for the clamping mechanism with the two pistons. All internal components are covered by a rusty red layer of corrosion, and the links of the adjusting chain are particularly severely affected. The brake cylinder mount and the spherical cup that is inside it are affected in the same way. The entire external surface of the brake calliper reveals a striking white covering.

The white colouring of the outside housing demonstrates that this vehicle has also been used on unconsolidated roads. The dust swirled up there combines with the frequent precipitation to create a mud that adheres to components underneath the vehicle in particular. This mud has a very small particle size, which means it can penetrate even the smallest gaps and lead to corrosion. In this case, it was presumably a defective brake cylinder boot that allowed the mud to penetrate and give rise to moisture in the brake calliper. This resulted in contamination and severe rusting, in particular in the adjusting mechanism.

Rust and mud residues soon spread throughout the interior of the brake calliper. The adjusting mechanism, the pistons and the clamping mechanism of the brake calliper have their movement severely restricted. The braking power is reduced and does not recover.

Leaks in brake cylinders are hard to spot from the outside. For this reason, shorter maintenance intervals are prescribed for off-road applications so that damage of this kind can be detected earlier.

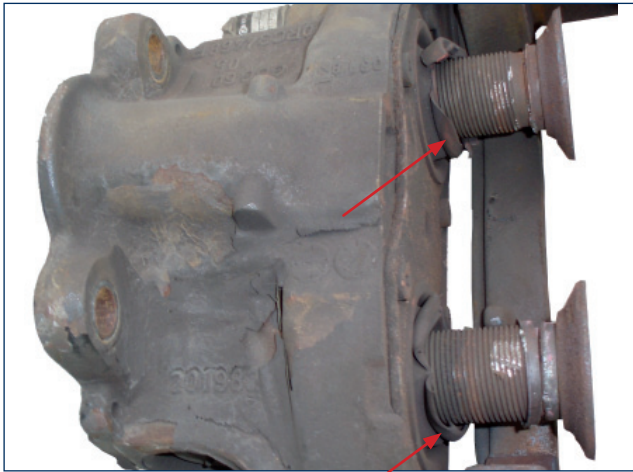
## 8.7 Damage pattern: Overheated boots

The picture shows the area of the clamping mechanism with the two pistons. The boots have been entirely scorched away.

Thermal overloading of the brake leads to overheating and destruction of the boots. If all wheel brakes are affected, it may have been caused by incorrect matching between the tractor and trailer, an aggressive driving style or a brake that is too small for the application. If only individual wheel brakes are affected, they may be faulty or there might be defects in the associated compressed-air brake circuits.

The damaged boot allows moisture to enter the interior of the brake, leading to corrosion. This soon spreads throughout the interior of the brake calliper. The functions of the adjusting mechanism and the pistons are significantly impaired with the effect that braking power is gradually lost as the level of wear increases. The result may be brake failure if the damage is not noticed and rectified in good time.

The pneumatic circuit and all components of the affected brake(s) must be checked. Overheated and damaged components must be renewed. We recommend using genuine parts. Check the matching between the tractor vehicle and trailer if necessary. A careful and predictive driving style can help to avoid overloadings of this type.

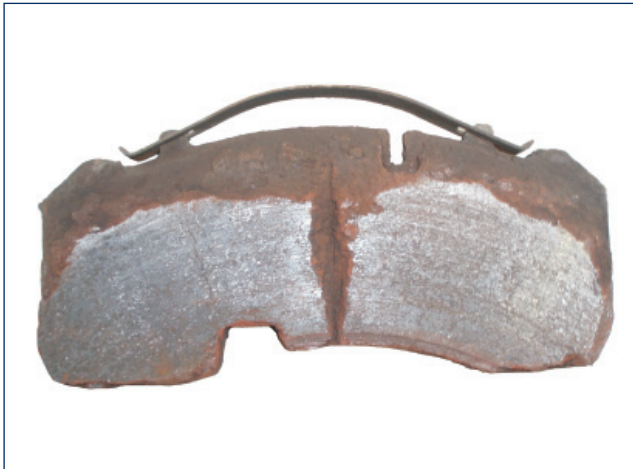
## 8.8 Damage pattern: Edge pitting on the pad

The pad has a remaining thickness of about half of the new condition. The pad halves are evenly worn down. A layer of carbon has formed on their surface due to the effect of friction, which is an indication of a brake that is functioning well. The pitting on the edges of the pads is a striking feature.

The cause of the pitting is splashing water penetrating to the brake pad in the area of the clamping clip, leading to corrosion. The corrosion causes the affected areas of the pad to swell, they lose their adhesion to the adjacent pad layers and are stripped off by the effect of the braking forces.

Edge pitting and cracks up to a certain extent (to about 10% of the pad surface) are signs of normal wear. The pad adhesion zone (pad thickness to 2 mm above the brake pad lining plate) is not allowed to have any pitting or cracks. Pads with greater levels of pitting must be renewed. We recommend using genuine parts.

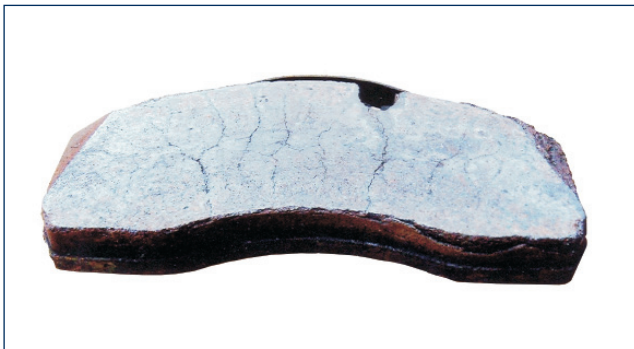
## 8.9 Damage pattern: Crack formation on a brake pad subjected to high thermal load

The brake pad thickness is almost still the same as the original thickness when new. This is indicated by the bevels on the left and right edges. The slanted surface on the right of the picture has been attacked by corrosion. Numerous heat cracks have formed on the surface of the pad. The crack depth is only slight in relation to the remaining pad thickness. Some crossways cracks have joined up and extend along the entire width of the pad. Only a slight layer of carbon has been caused by friction on the pad surface.

The pad has been subjected to short, sharp braking. There have been very high temperatures on the surface, but because of the fact that the loading only occurred briefly these temperatures did not penetrate into the deeper layers of the pad. This superficial heat caused the binding agents to become vaporised and heat cracks resulted.

The cracked surface will be abraded off relatively quickly during driving, which means the wear limit can be expected to be reached prematurely. The heat cracks are a sign of elevated thermal loading, but are not critical in themselves.

There is no need to renew these pads providing the cracks do not extend into the area of the pad adhesion zone and do not run horizontally to the lining plate.

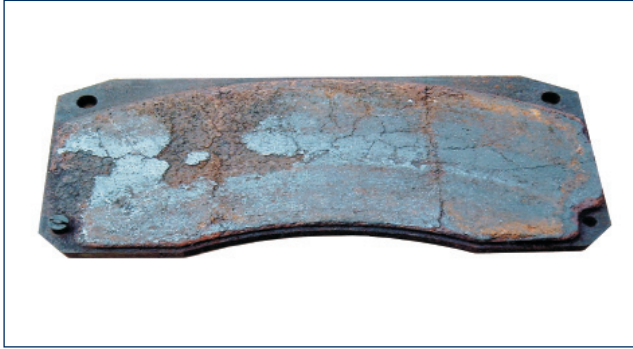
## 8.10 Damage pattern: Brake pad at the wear limit

The friction lining of this pad has reached the wear limit. Its remaining thickness is only two millimetres. The picture shows marked heat cracks on the pad surface. The binding agents have already vaporised at a few points on the pad and parts of the pad surface have broken off. The broken areas have been attacked by corrosion.

The pad used has a typical wear pattern without signs of overloading. The pad has already worn down to the pad adhesion zone (remaining pad thickness 2 mm).

Adequate braking values can still be achieved in the lower to middle area of the pad. If the brake pad is not renewed immediately, there is a danger that the remaining pad will lose its adhesion completely during full-on braking and may also flake away. The brake would fail.

The pad must be renewed because the brake pad has reached its wear limit. We recommend using genuine parts. BPW disc brake axles can have the Brake Monitor retrofitted to them. This can be attached in a clearly visible location on the vehicle and indicates when the brake pad wear limit has been reached.

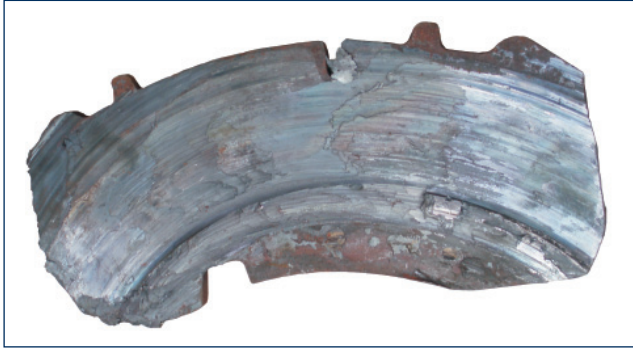
## 8.11 Damage pattern: Disregarding the wear limit

This brake pad lining plate has been in direct friction contact with the brake disc over its entire area. None of the pad's friction lining remains. The even abrasion on the brake pad lining plate indicates even clamping by both pistons, so the adjusting mechanism is undamaged.

The wear limit of this pad has been significantly exceeded. The direct friction contact between the brake disc and the brake pad lining plate led to temperatures in the forging and smelting range at some points.

After the wear limits have been exceeded, the pads and the brake discs are irreparably damaged (see page 21). In addition, there may be damage to the brake calliper and complete failure of the brake might result.

Pads that have reached their wear limit must be renewed. Other components of the brake must be checked for damage and renewed if necessary. We recommend using genuine parts. It is essential to respect the wear limit!

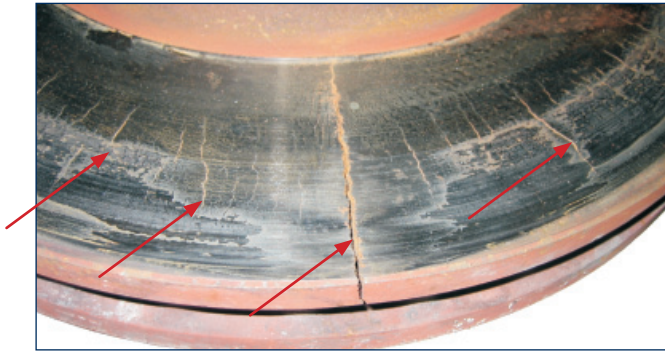
## 8.12 Damage pattern: Thermal overloading with cracking of the brake disc

The damage pattern shows a crack through a ventilated brake disc; the disc itself displays little wear. Furthermore, the brake disc reveals heat cracks due to high thermal load.

Thermal overloading of this kind is caused by excessively frequent, intermittent sharp braking. This results in high levels of alternating thermal loads which give rise to internal stresses leading to a crack through the brake disc. Other possible causes can be identified as incorrect matching between the tractor vehicle and trailer or overloading of the trailer.

The cracks through the brake disc reduce its stability. Under extreme circumstances, the brake disc can fracture, resulting in complete brake failure.

The thermally overloaded disc must be renewed. The other components of the brake must be checked and renewed if necessary. We recommend using genuine parts. Correct matching between the tractor vehicle and trailer, avoiding overloading and driving with a careful, predictive style can help to avoid such damage.

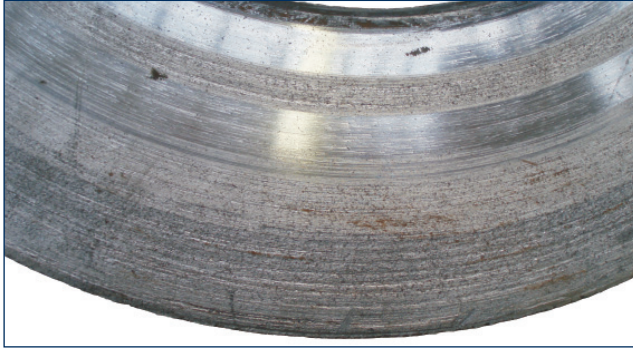
## 8.13 Damage pattern: Thermal destruction of the brake due to extreme brake pad wear Component: Bremsscheibe

The picture shows a brake disc with its surface covered by fused metal.

The cause of damage such as this is failure to respect the brake pad wear limit. If the brake pads are worn down to such an extent that the brake pad lining plates come into contact with the brake disc during braking, this gives rise to temperatures in the smelting range at some points and the braking surface can melt there (see page 19). The molten metal is smeared over the surface of the disc.

The brake disc exceeds the permitted limits of wear and scoring. If braking continues in this condition, overheating can result in further damage and ultimately total failure of the brake.

Brake discs with excessive levels of scoring must be renewed (see wear assessment on page 8). Other components of the brake must be checked for damage and renewed if necessary. We recommend using genuine parts.

It is essential to respect the wear limits of brake discs and brake pads.

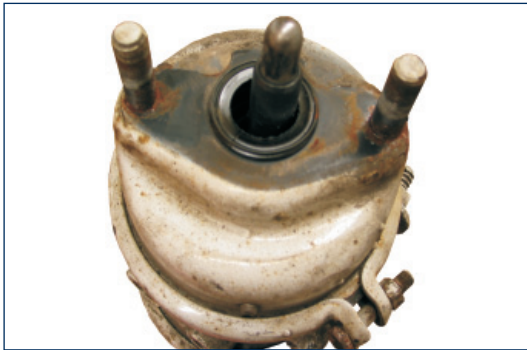
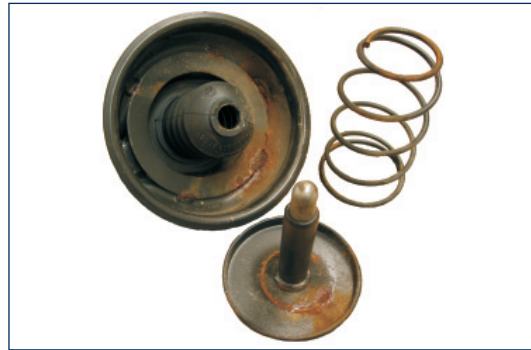
## 8.15 Damage pattern: Corrosion in the brake cylinder

The picture shows a spring-loaded diaphragm brake cylinder of a disc brake. A striking feature is the misalignment of the piston that protrudes out of the screw-on surface towards the brake calliper. When opened for assessment, the brake cylinder reveals corrosion to the compression spring, piston and housing cover.

No drainage hole was opened on this brake cylinder. This means the moisture that enters the cylinder with the inflow of atmospheric air was unable to escape and gave rise to corrosion on the components. The piston shown in the left-hand picture is slightly misaligned.

A heavily corroded compression spring can break under load and damage both the diaphragm and the boot. This would result in moisture penetrating the brake calliper leading to corrosion and associated stiffness with a loss of braking power. Furthermore, the broken fragments of the spring can prevent the return movement of the piston and thereby impair the release of the brake.

With brake cylinders, it is essential to make sure that the lowest drainage hole is opened. The other holes must remain closed. Brake cylinders are only allowed to be serviced and repaired in an appropriately equipped specialist workshop. For reasons of safety, never open spring-loaded accumulators!

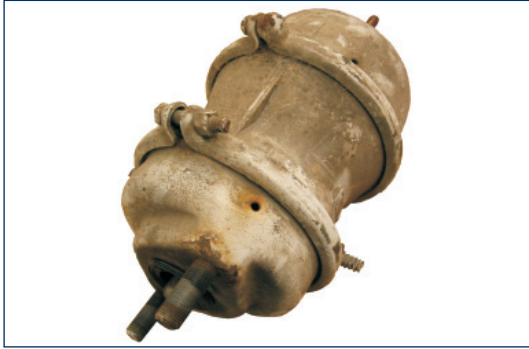
## 8.16 Damage pattern: Leakage in the area of the clamping band

This spring-loaded diaphragm brake cylinder is losing air in the area of the clamping band for the service brake section.

Diaphragms are wearing parts and subject to an ageing process. After several years of operation, leaks can result in the clamping area of the diaphragm and the clamping band, leading to a gradual pressure loss.

In spite of the leak, there is no reason to expect sudden total failure of the brake cylinder and therefore of the wheel brake. The air only escapes slowly. The drop in reservoir pressure is made good when the vehicle is driven. If the vehicle is parked up for a long time, however, all the pressure in the service brake system can escape and require re-establishing. The parking brake system will thus remain activated for longer.

Defective brake cylinders must be renewed. We recommend using genuine parts.
