AirSave tyre inflation system changes

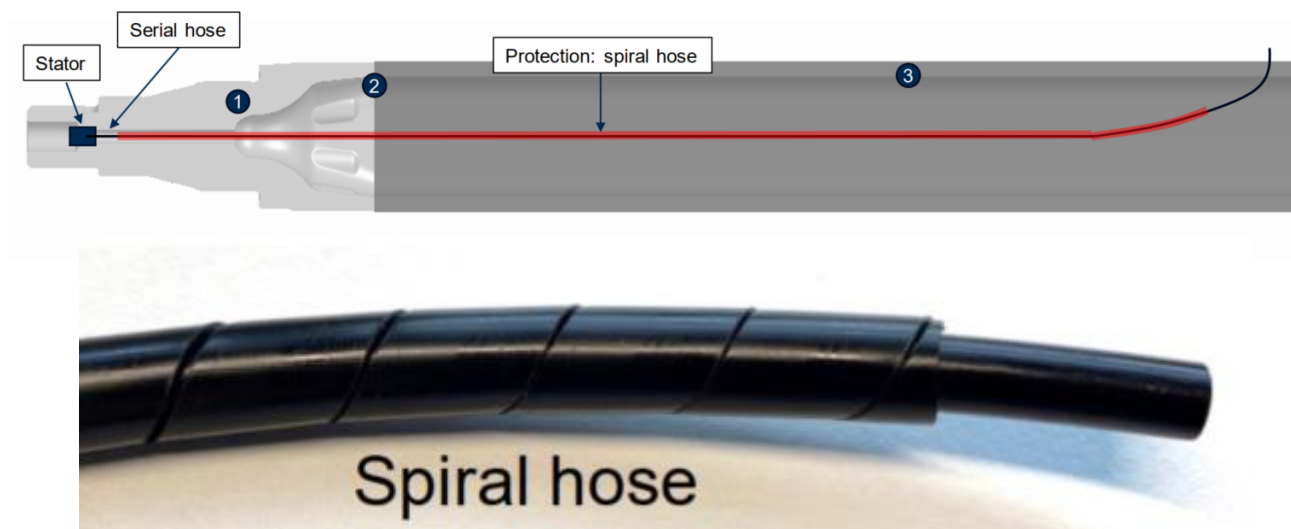
BPW will be introducing a protection sleeve which is to be fitted to the 6mm piping in the beams as shown in Figure 1. This solution is set to minimize the amount of movement that is introduced through any vibrations in the beam, as the pipe will be stiffened and the clearance inside the hole is significantly reduced. This addition will therefore reduce the chances of any piping ruptures due to vibrations and rubbing in the beam.

Figure 1: New spiral hose being fitted on the 6mm piping in the beam

The spiral guard introduced to the piping kit will be 70mm shorter than the inner pipe, allowing for 35mm of clearance on either side of the stator and elbow fittings, which are attached to each end. The material selected for the spiral hose has a maximum operating temperature of 120°C, providing peace of mind when the trailers need to cover large distances or navigate harsh routes with increased vibration and braking frequency.

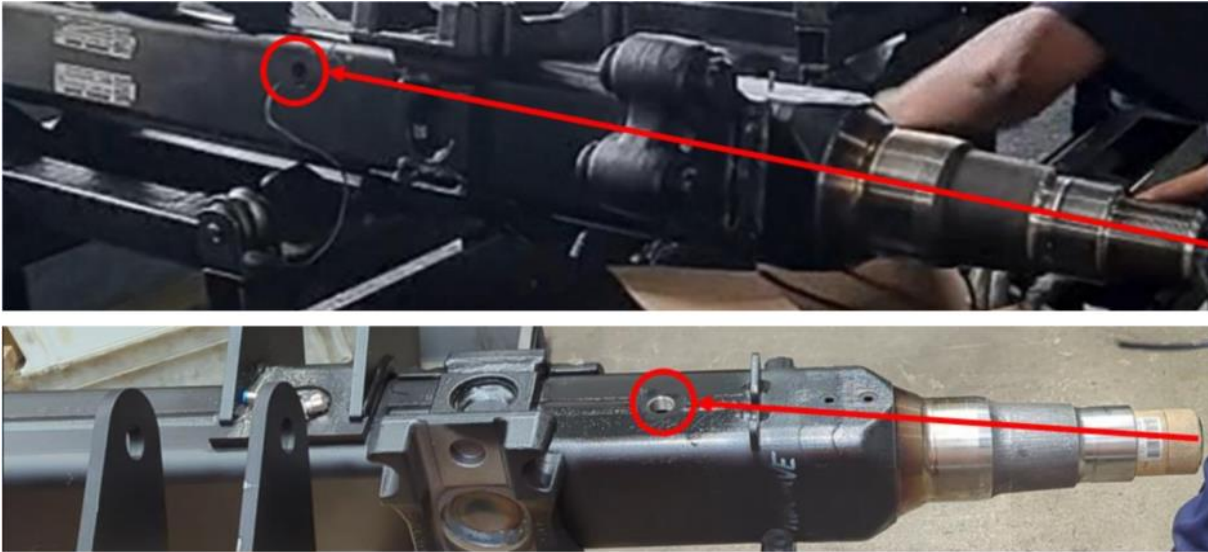
BPW Axles is also in the process of changing the locations at which the exit hole is drilled on the rear side of the AirSave axle beam to be located between the spring seats and the wheel end, as opposed to both holes being located between the spring seats as shown in Figure 2 and Figure 3. Locating the exit hole between the spring pad and wheel end will become the new standard, and

Figure 2: Top- exit hole on beam located between two spring pads. Bottom- Exit hole located between spring pad and wheel end

only on special request will the hole location be moved between the spring pads. BPW Axles will be updating layout drawings to show the possible hole locations and standard locations.

This change in the hole location offers a twofold benefit to the AirSave operations: it reduces the amount of piping inside the beam and minimizes the resulting movement caused by any slack introduced during the installation process. Secondly it assists in clearing up the space between the inside of the spring seats, which often co-insides with the location of the fitment of the axle catch straps which some trailer builders opt to have fitted for safety reasons.

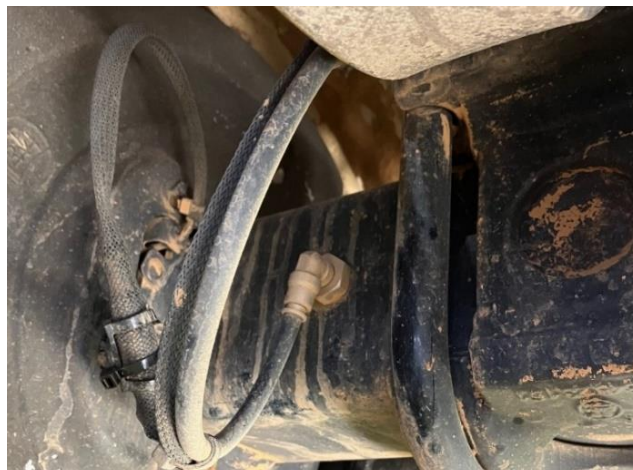
Figure 3: Example of the new exit hole location on an axle
