# Wear and damage characteristics on friction brakes

- Drum brake -

1<sup>st</sup> edition / 2007

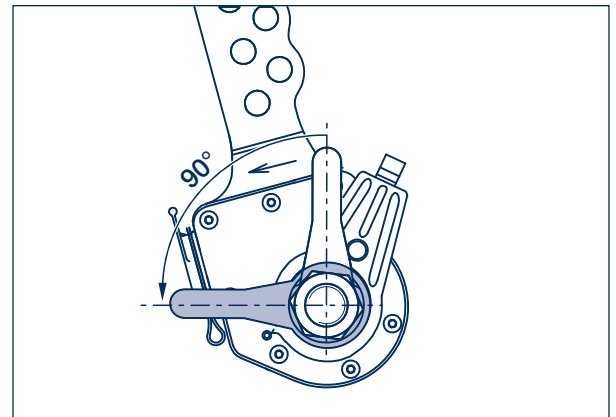
In the case of BPW's drum brake axles, which are equipped with the AGS ECO-Master with wear indicator, the state of wear of the brake linings can be easily detected. If the wear indicator has rotated by approximately 90° with respect to its starting position, the brake linings have almost reached their wear limit and must be renewed.

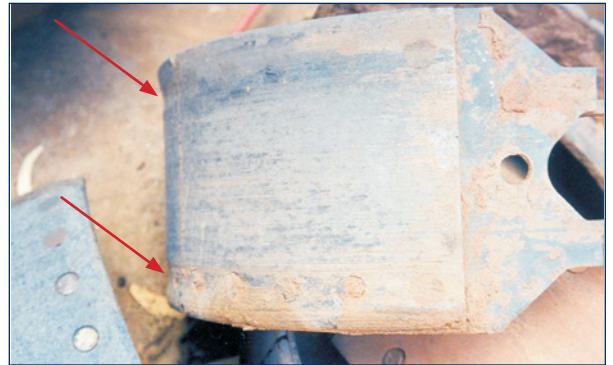
## 8.6 Damage profile: Scoring at rivet hole intervals

The damage profile shows the inner face of a brake drum. Unusually, the scoring which is pronounced to varying degrees is on the brake contact surface. The brake drum is particularly worn in the area of the brake linings' rivet holes.

If dirt and moisture penetrate the brake as a result of defective or missing dust covers, the action of pressure and temperature can result in the formation of a wear-resistant compound similar to clay brick in the rivet holes.

As the wear of the brake linings increases, this compound works its way into the brake drum and causes the severe scoring in the area of the rivet holes.

If the permitted wear limit of the brake drum is exceeded, this can have the effect of weakening the brake drum.

A brake drum which is damaged in this way must be renewed. It is recommended that genuine components be used.

It is crucially important that the dust covers are in perfect condition, particularly when operating on unpaved roads.

The condition of the dust covers must be regularly checked.

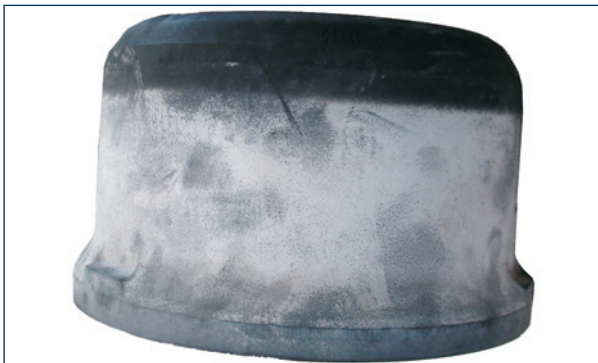
*Scorches and temper colours with heat cracks starting to form*

The figures show brake drums which have scorches and heat cracks with varying degrees of severity. These scorches and heat cracks are on the brake contact surface and are caused by thermal stress or overloading. The top figure shows the white colouration of the burnt coating, and the lower figure shows an extremely reddish layer of corrosion, on the outer surface of the drum.

Heat cracks and scorches are signs of a thermally highly loaded or overloaded brake.

Such overloading often occurs as a result of severe braking from high speeds. This occurs particularly frequently during inappropriate and aggressive driving. The brake contact surface is heated up considerably and very rapidly, whilst the outer area of the brake drum is still relatively cold. These high temperature differences result in a plastic deformation of the inner surface, resulting in visible cracks occurring during cooling.

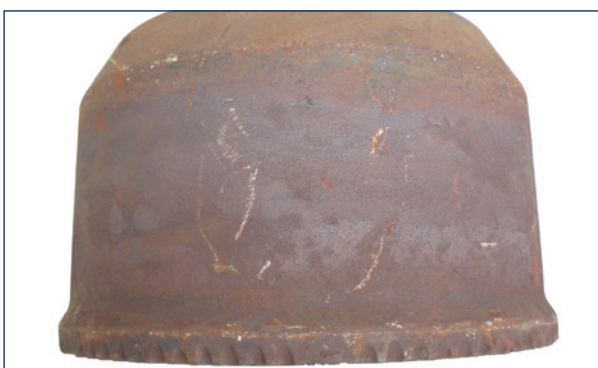
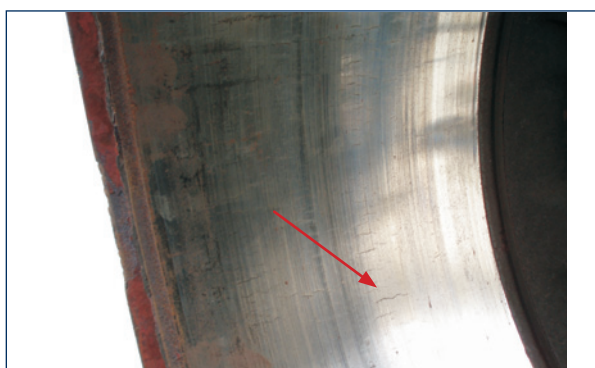
*Severe heat crack formation*

Deeper cracks extending into the edge area of the brake contact surface or which connect together to form longer cracks reduce the stability of the brake drum. Such cracks can, in extreme cases, lead to the fracture of the brake drum.

Brake drums with severe heat crack formation must be renewed. It is recommended that genuine components be used.

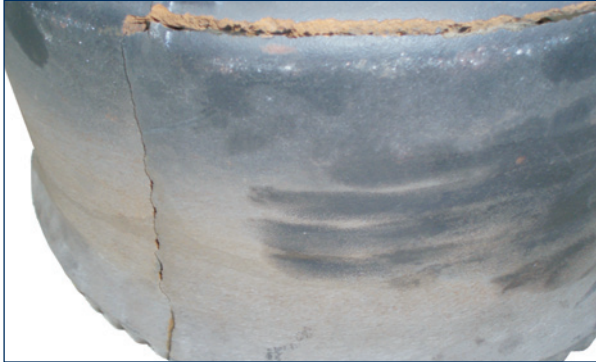
## 8.8 Damage profile: Cold fracture of a brake drum

The figure shows a fractured brake drum. The original coat of paint is still in place, which shows that the brake drum has not experienced any thermal loads or has only experienced slight thermal loads. The mileage is low.

Hairline cracks can occur in the brake drum as a result of poor handling, severe impacts or other use of force during the transportation of the axle. If these are only very small or inside the structure, it is possible for them to be overlooked when the brake drums are fitted on the vehicle.

The scarcely visible hairline crack expanded in the material during heavier braking and resulted, in the end, in the destruction of the brake drum.

If such damage exists the brake drum is to be immediately renewed.

If there is any suspicion of damage prior to installation of the brake drum, it should not be used for safety reasons.

Despite their robust construction, it is essential that axles and brake drums are handled carefully, in order to avoid causing prior damage to them.

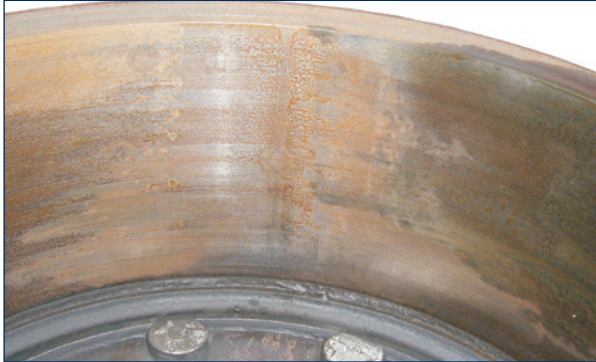
## 8.10 Damage profile: Brake contact surface corrosion

The brake drum has slight surface rust on the brake contact surface. The contact area of the brake linings with the brake drum can be clearly seen.

If moisture penetrates the brake as a result of cleaning with high-pressure cleaners or during wet weather, particularly near the sea, surface rust may possibly form on the brake contact surface within a matter of only a few hours.

The surface rust does not have any detrimental effect on the braking power and the component service life, as this slight rusting is worn away during subsequent braking operations.

No particular remedial measures are required in the case of the formation of surface rust.

In the case of more severe corrosion, e.g. following long laid-up periods, the brake drum must be renewed. It is recommended that genuine components be used.

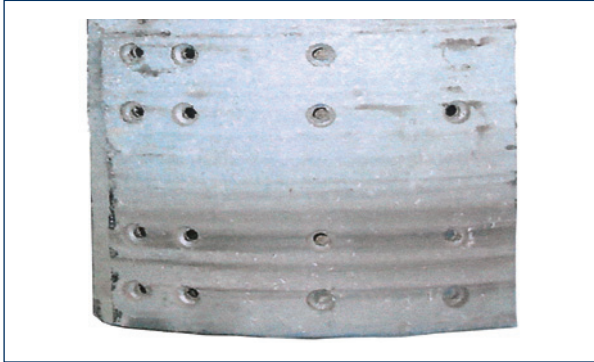
## 8.11 Damage profile: Scoring and uneven wear due to dirt

The linings shown are considerably worn and scored. The scoring runs over the entire surface of the brake lining. The average lining thickness still has a large amount of wear left.

The cause of such damage is generally driving on unpaved or dirty roads with damaged or missing dust covers. The dirt whirled up can get into the brakes and lodge itself between the brake linings and brake drum. The rotating motion causes the sand and grit particles to be ground between the brake contact surfaces of the brake drum and the brake lining and causes the scoring which can be seen. (Please also see page 14).

The particles of dirt in the brake wear the brake drum and brake lining very quickly and unevenly. In addition, the formation of friction carbon on the lining surface is prevented. The layer of friction carbon increases the friction between the brake drum and brake lining and therefore also the braking power. Without friction carbon, the brake loses effect. In the worst case, all of the brakes of the vehicle provide different braking power.

In the case of severe scoring, the components affected are to be repaired or renewed. It is recommended that genuine components be used.

It is crucially important that the dust covers are in perfect condition, particularly when operating on unpaved roads. Stone chips can result in deformations and damage to covers, through which dirt is able to penetrate the brakes and cause damage.

The condition of the dust covers must be regularly checked.

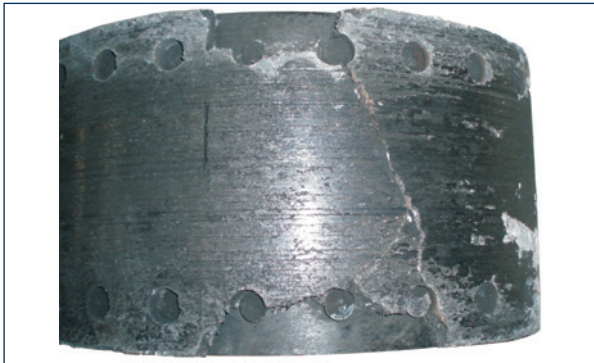
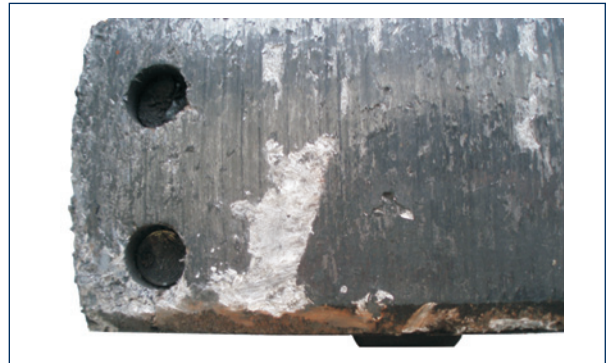
## 8.12 Damage profile: Thermal overloading of the brake linings

The damage profiles show a thermally overloaded brake lining. It has incipient cracks and tears in particular in the area of the rivet holes. The breaks are no longer within the permissible range. The brake lining has not yet reached its wear limit.

Thermal overloading is responsible for the damage to the brake lining. There may be various causes for this:

If all the brakes of the vehicle observed have a similar wear profile, a defective tractor/trailer synchronisation or inappropriate and aggressive driving may be the cause of the thermal overloading of the brake.

If only one wheel brake shows signs of thermal overloading, a defect in the adjusting device or in the brake circuit may have prevented the brake from being released, resulting in the brakes overheating (see page 10).

The overheating causes the lining binding materials to decompose, so that the lining structure changes and the lining wears more quickly. In addition, the lining becomes porous and cracks and breaks, which can in extreme cases, result in the total failure of the brake.

Brakes with such a damage profile should be renewed including the wheel bearings and seals. It is recommended that genuine components be used.

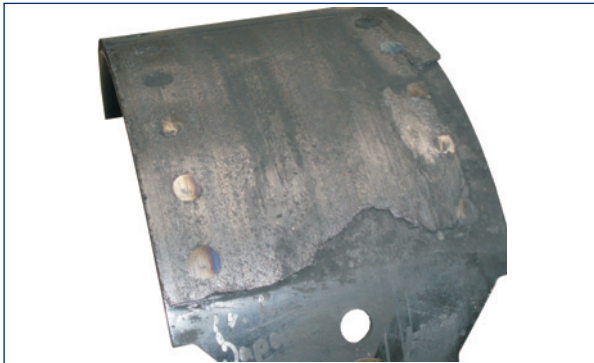
## 8.14 Damage profile: Brake lining below the permissible minimum thickness

This brake shoe has been worn beyond the wear limit. The surface of the brake lining shows an even wear pattern without any signs of thermal or mechanical overloading. The rivet heads are considerably ground down. Parts of the brake lining have been torn off.

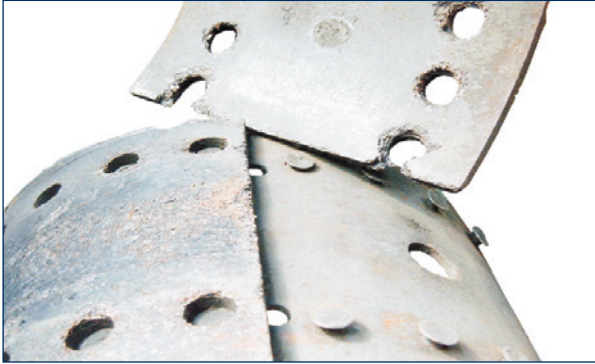
## 8.15 Damage profile: Detached half of brake lining as a result of too high rivet forces or incorrect rivet sequence

The figure shows a brake shoe with a completely detached lining half. The bases are torn out in the area of the lining's rivet holes, the rivets are still in the brake shoe's holes.

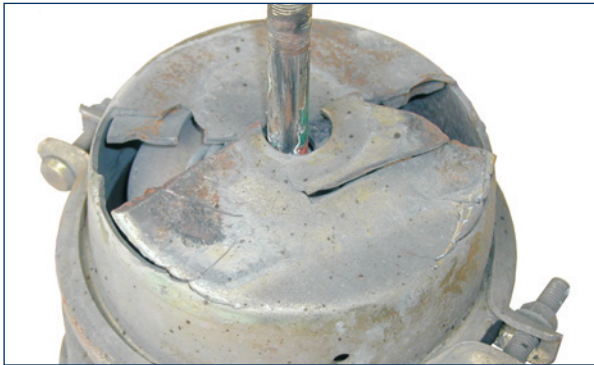
## 8.17 **Damage profile:** **Brake cylinder mounting face torn out due to loose screw connection**

The screw fixing stud(s) of the brake cylinder are torn out. Signs of a fatigue fracture can be seen on the fracture surfaces of the brake cylinder.
